US Army Corps
of Engineers

USACERL Technical Report 95/02
May 1995

Thermal Energy Supply Optimization for Aberdeen Proving Ground-Edgewood Area

Distribution System Condition Assessment and Recommendations

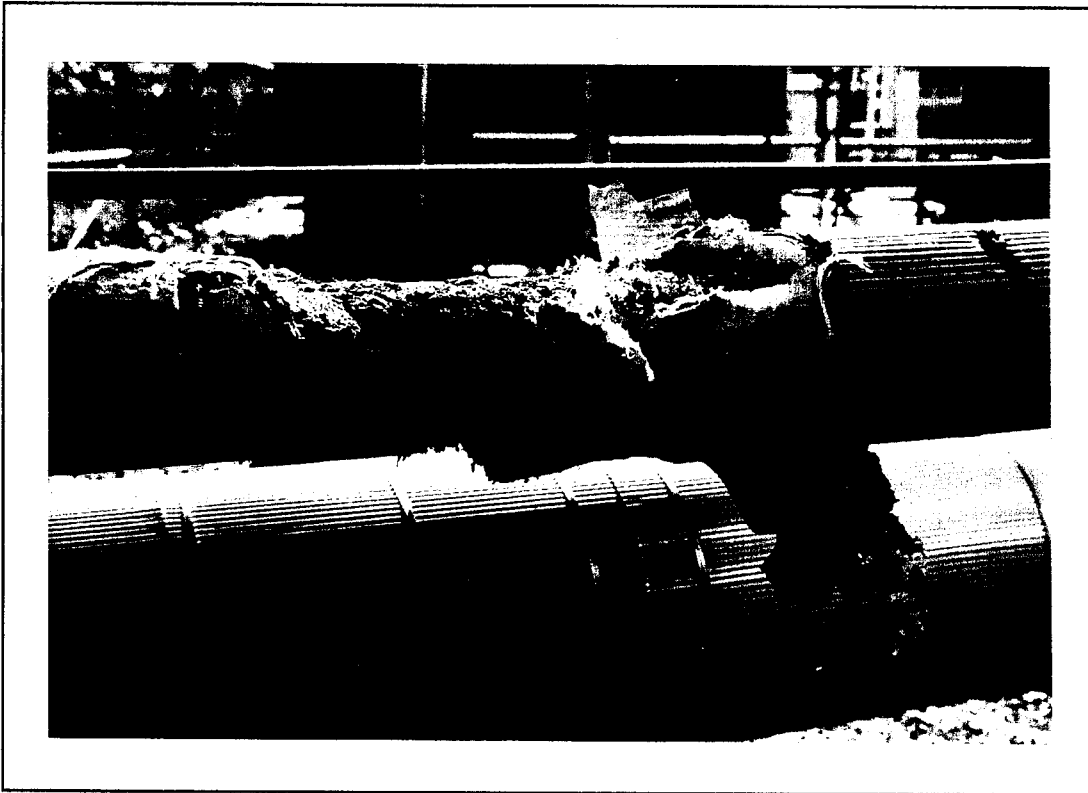
Figure 1. Deteriorated insulation on section 3312-37A near Bldg E3370.

The 4 in. condensate return line in the 3000 area extending from the boiler plant to near Bldg 3725 (section ID 3312-37A) was inspected in the area of Bldg 3370. The condensate line is severely corroded and is in extremely poor condition. Several leaks and areas of steaming were observed (Figure 6). Most of the leaks were along the top of the pipe. The insulation was badly deteriorated. Insulation was removed from the lines in several locations, and visual inspection revealed that the lines were corroding

from the outside. This observation was supported by the fact that most leaks were on the top area of the pipe. If corrosion was being caused by the condensate acting from the inside, most of the leaks would appear along the bottom of the pipe. Most likely, the severe corrosion along this section is due to wet insulation at the pipe surface. The steam lines were in fair condition. In addition, there was excessive vegetation, including several trees, growing between the steam and condensate line (Figure 7). This vegetation should be removed. Areas of missing insulation were also observed (Figure 8).

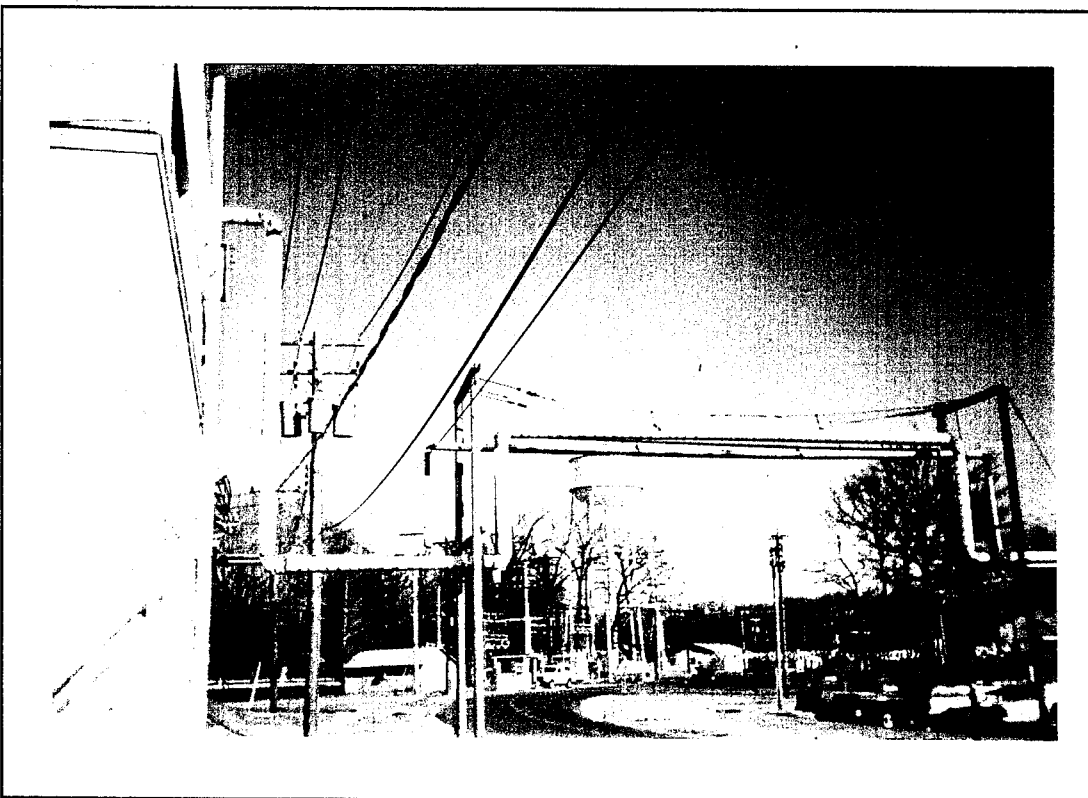
An estimated 2,000 ft of aboveground piping, ranging from 2 to 6 in. in diameter, was found to be without insulation. In addition, there are numerous sections (such as that shown in Figure 1) where insulation and insulation covering are damaged. Missing insulation is particularly a problem at pipe elbows. Figure 2 shows an example of this.

Figure 2. Typical example of missing insulation on pipe elbows near Bldg E3312.

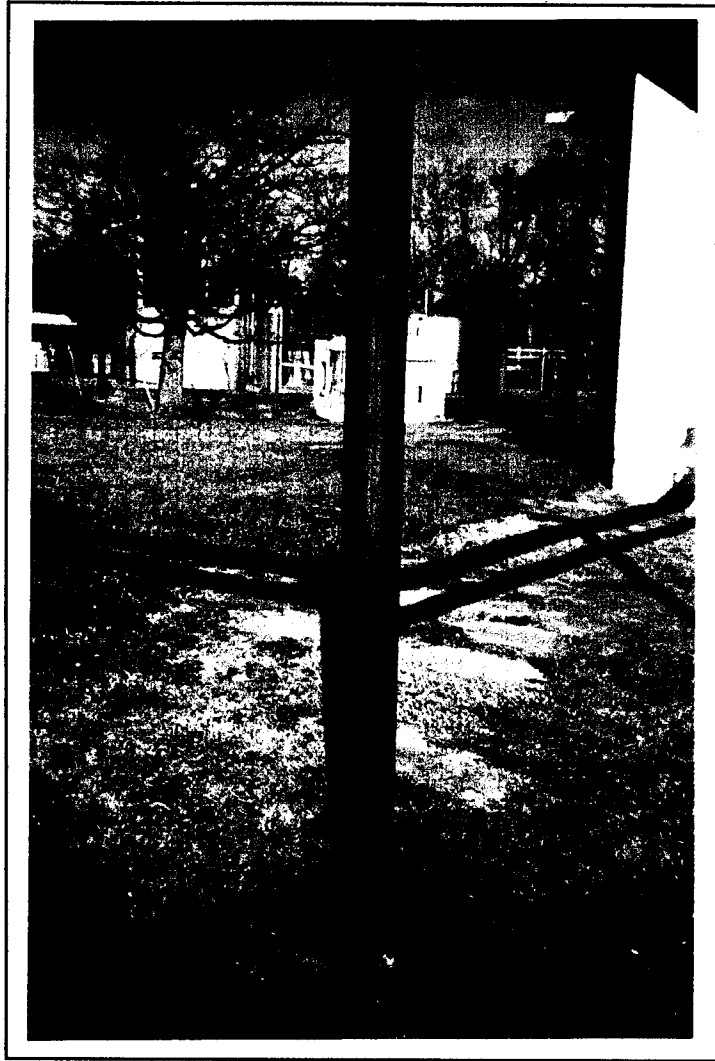
Many of the metal support poles are in need of recoating. Figure 3 shows a typical example of deteriorated coating on support poles. An important issue here is the possible presence of lead-based paint. Testing on one of the poles supporting the aboveground piping indicated the presence of lead. One test does not provide enough

data from which to draw conclusions, but it is important to be aware of the possibility that lead-based paint might be present when maintenance is performed or coated components are replaced or demolished. Recommendations pertaining to managing lead-based paint can be found in Chapter 4 under "Recommendations."

Figure 3. Typical example of deteriorated coating on support pole near Bldg E3312.

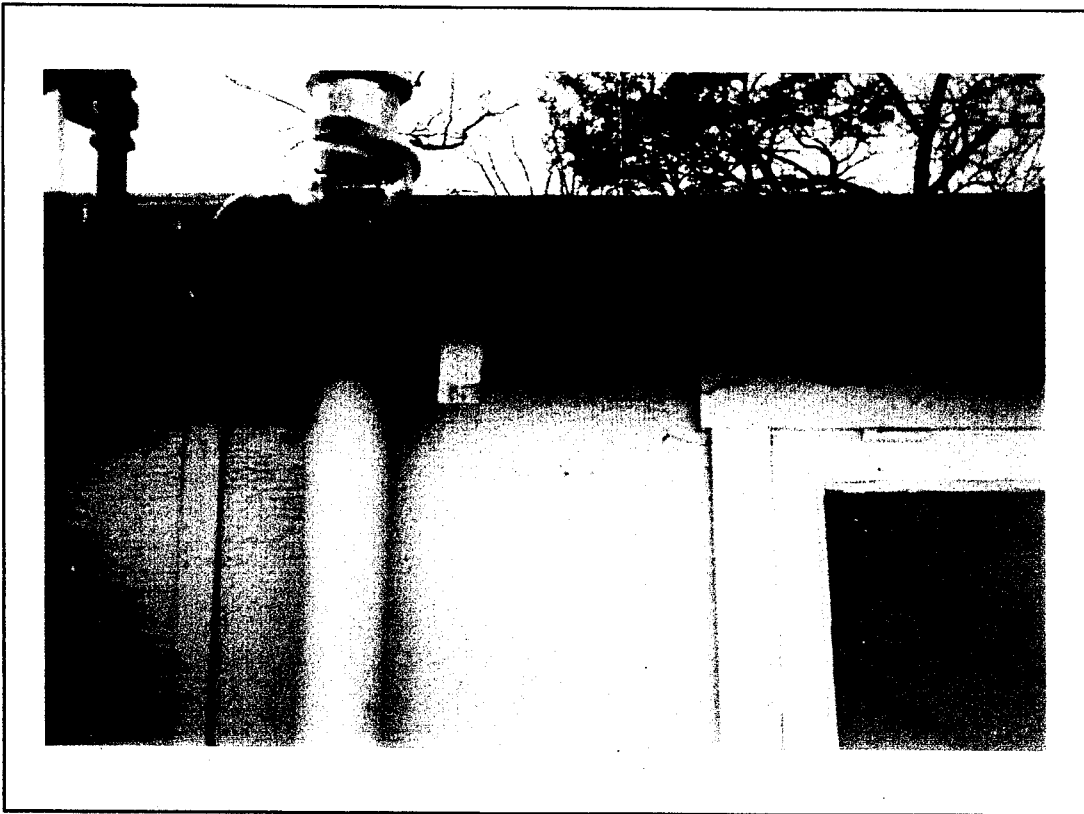
Many of the pipe guides and supports on the low profile aboveground lines were damaged and did not function as designed. Other locations were observed where "substitute" supports had been used. Figure 4 shows a location where a cloth strap was used to support a pipe. This practice should be discontinued. Figure 5 shows an example of a pipe that was not resting properly on support rollers. As noted above for piping anchors, this deficiency can result in unacceptable stresses and possible pipe or fitting damage.

Figure 4. Improper pipe support at Bldg TE3613.

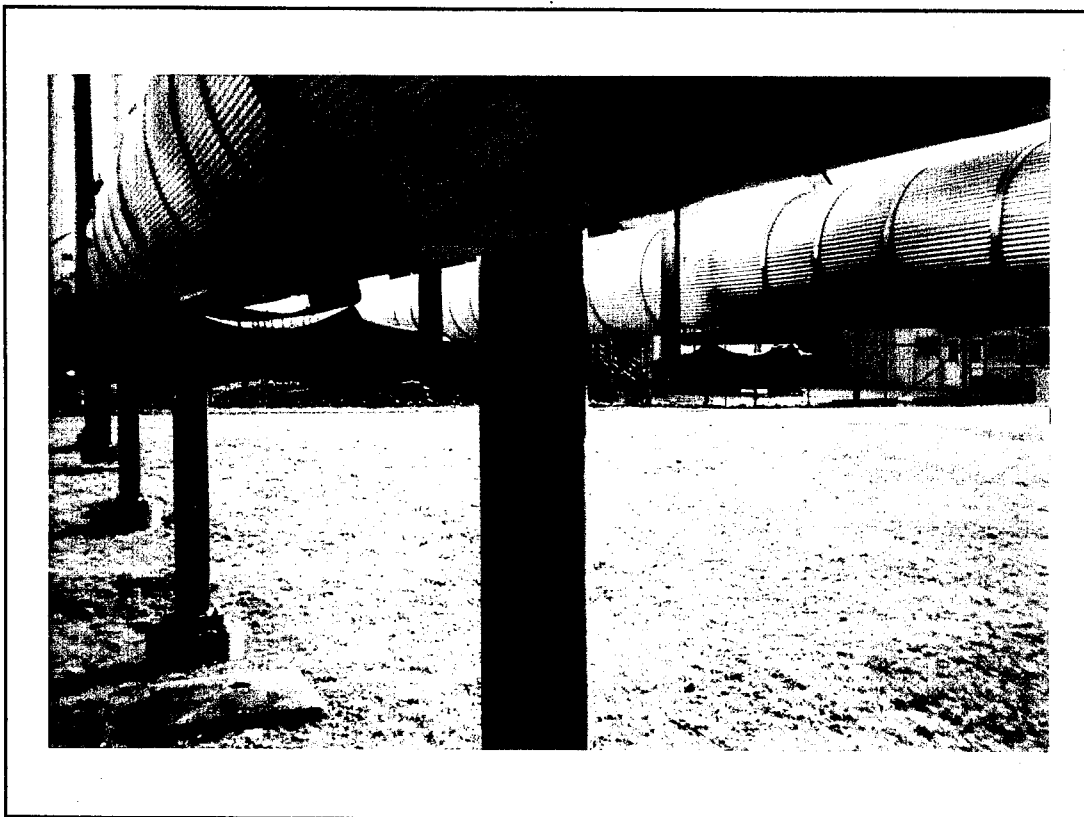
Figure 5. Typical example of pipe not resting properly on support rollers on line to Bldg E3570.

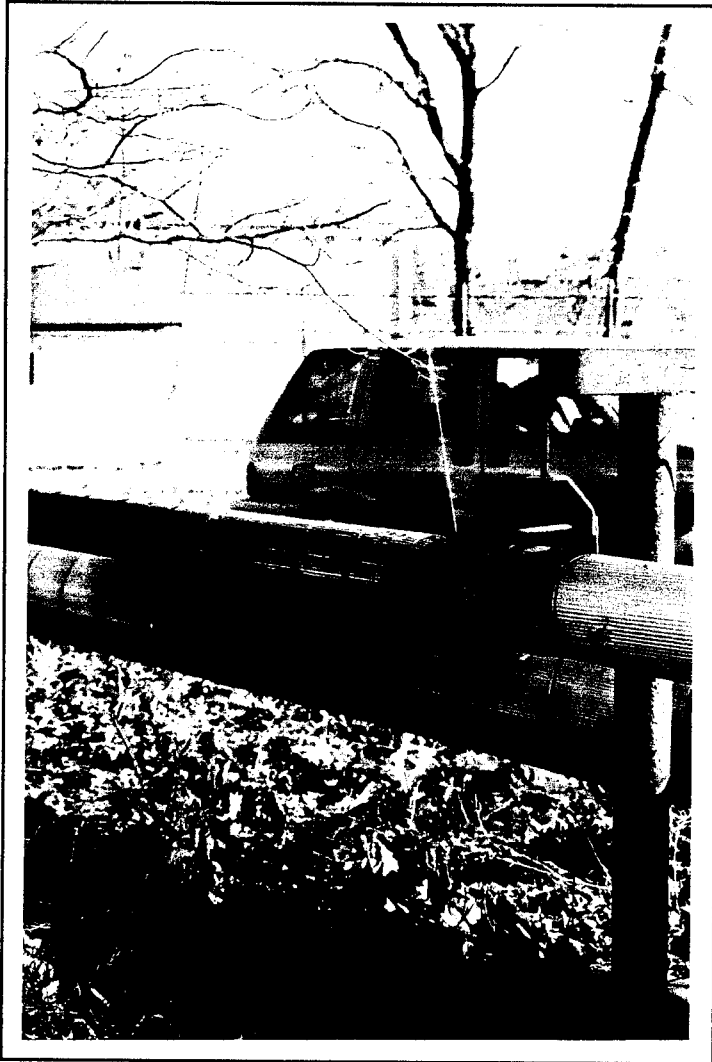
Figure 6. Condensate line leak near Bldg E3607.

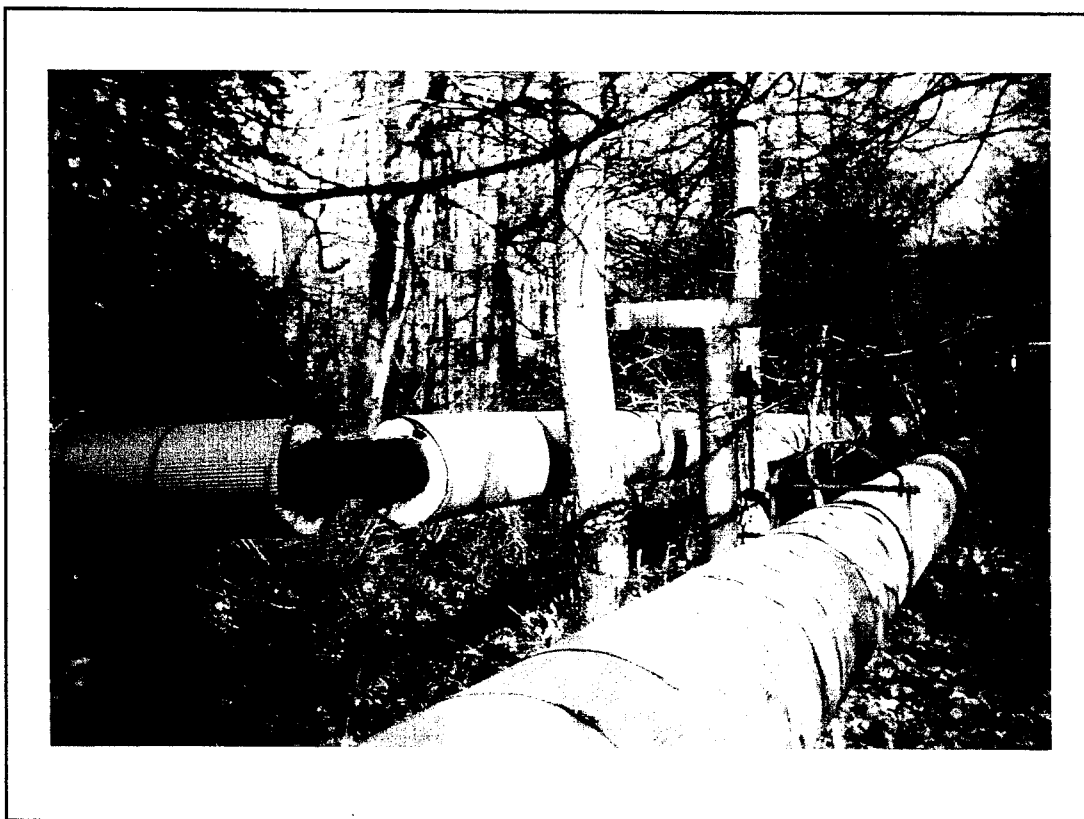
Figure 8. Trees growing between lines and missing insulation on pipe elbows on Section 3312-37A.

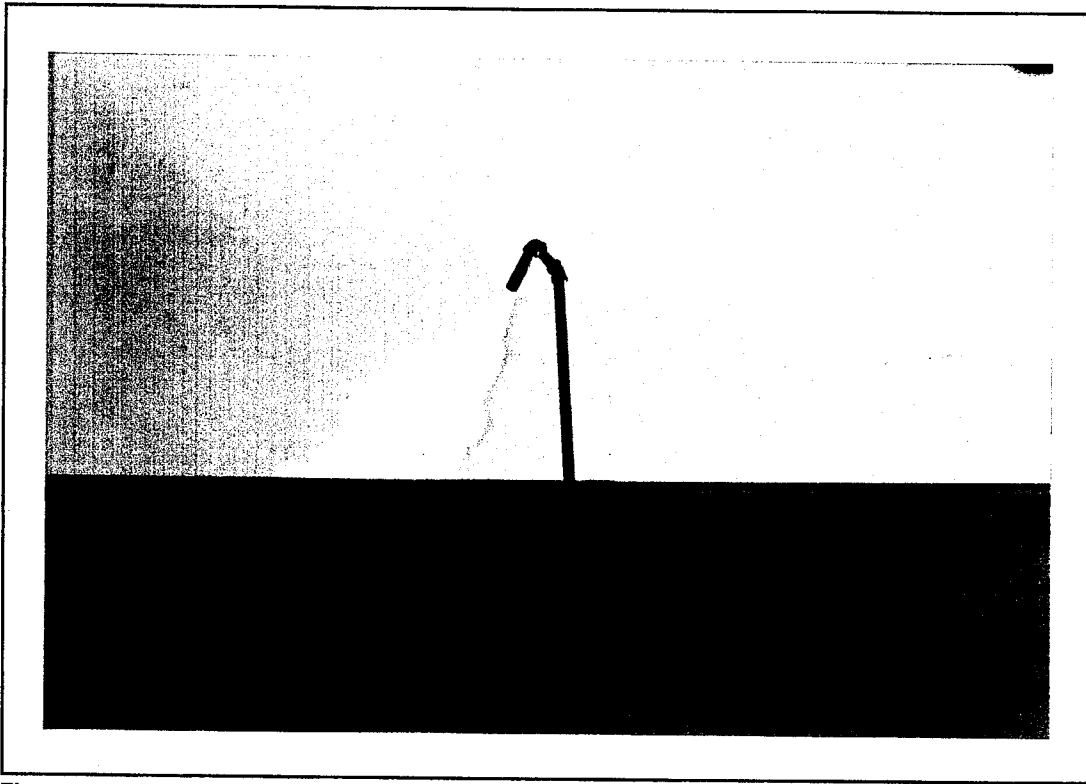
Figure 9. Failed steam trap at Bldg E3516, reportedly replaced 3 years ago.

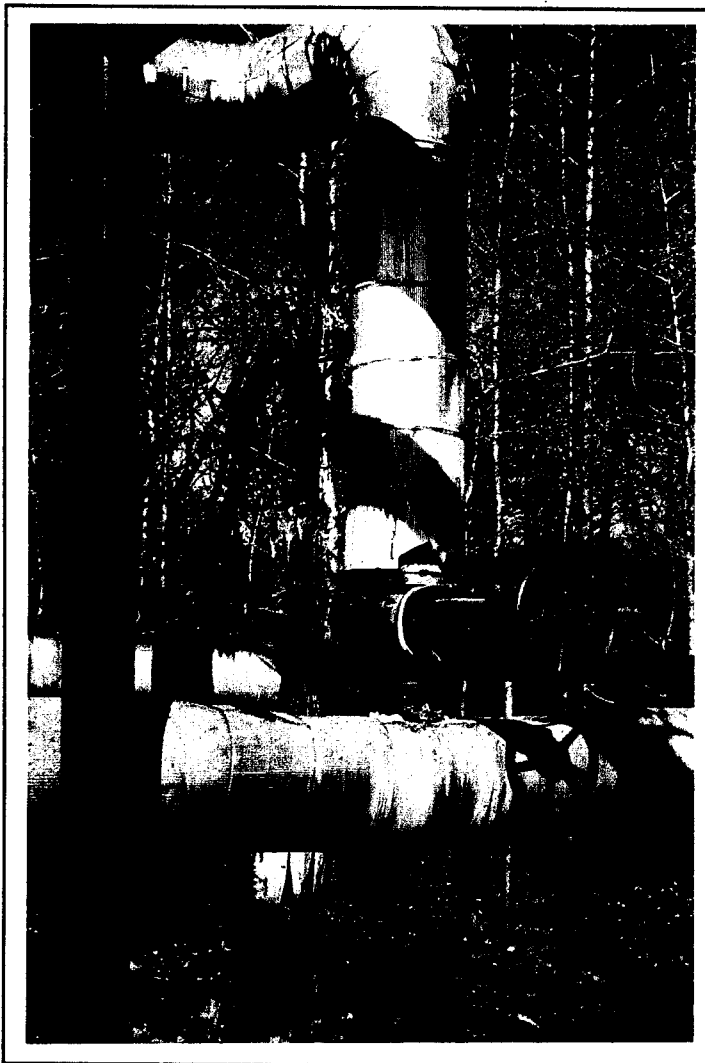
Other defects observed were leaking flange gaskets (Figure 10) and leaking valve packing (Figure 11). These defects also cause significant heat loss. Figure 12 shows a condensate tank resting directly on the ground. Contact with the soil will accelerate the failure of this tank due to corrosion. In addition, Figure 12 shows a typical case of missing pipe insulation.

Figure 10. Leaking flange gasket at junction between old and new system near 3300 area.

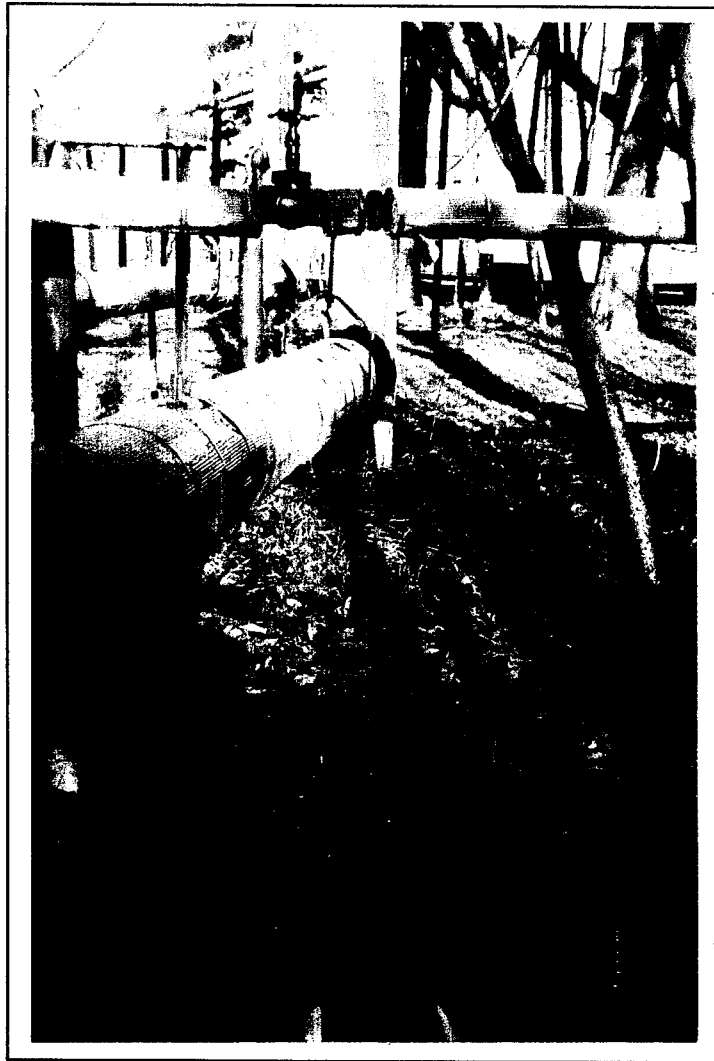
Figure 11. Leaking valve packing on 2 in. return line from Bldg E3580.

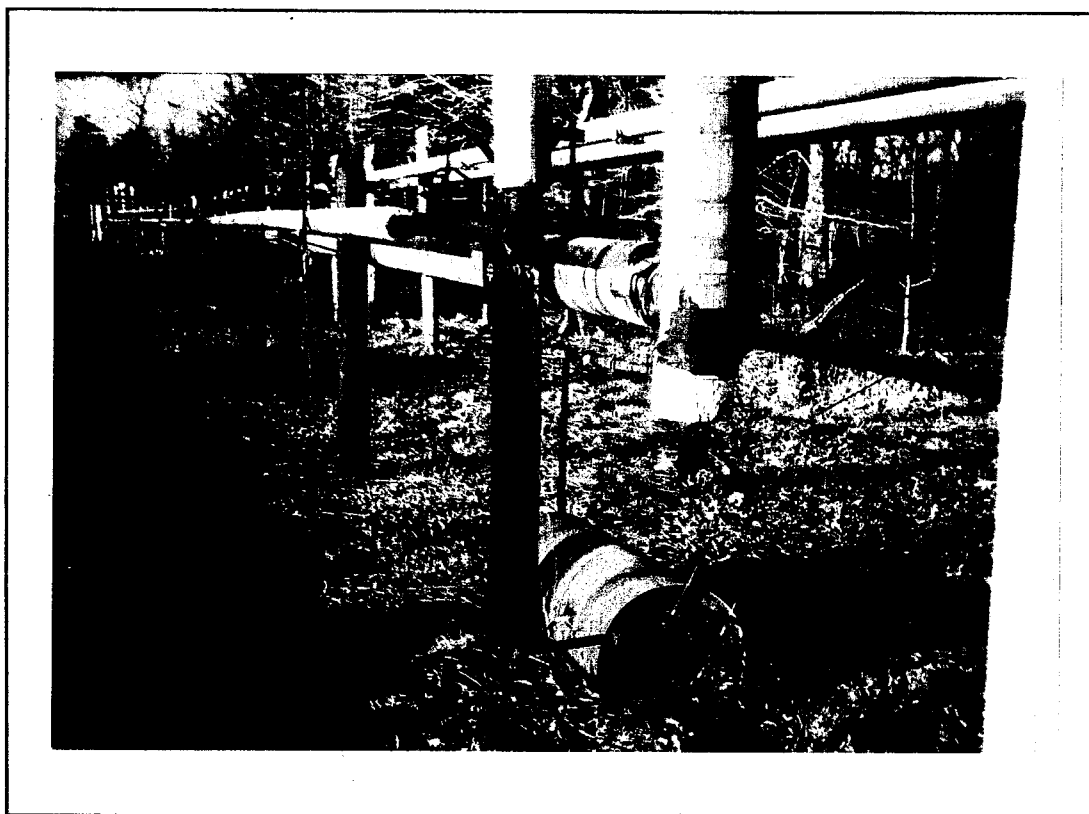
Figure 12. Condensate tank resting on the ground near Quonset huts in 3000 area, with insulation missing from pipe.

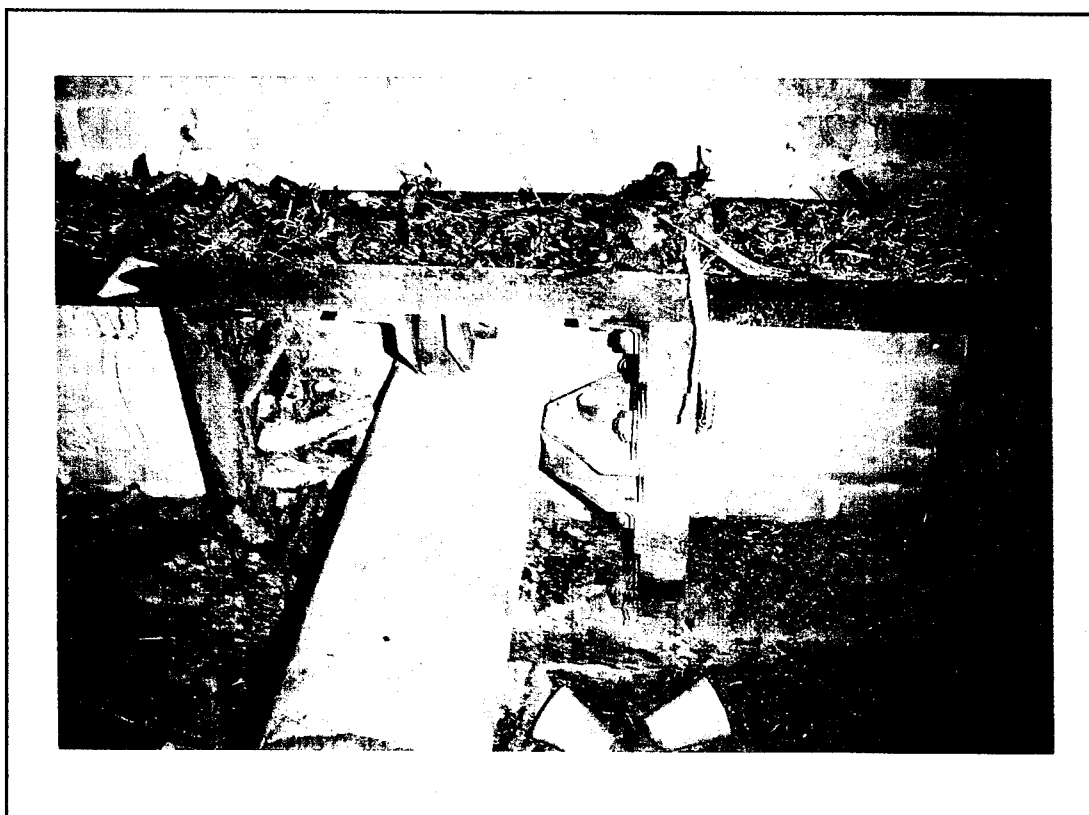
Many of the screens on the manhole tops are missing and should be replaced to prevent the manholes from collecting debris. Figure 13 shows an example of a manhole containing excessive debris. Such debris can prevent or severely impede the drainage of water from the manhole.

Figure 13. Typical example of excessive debris in manhole (no. 5320).

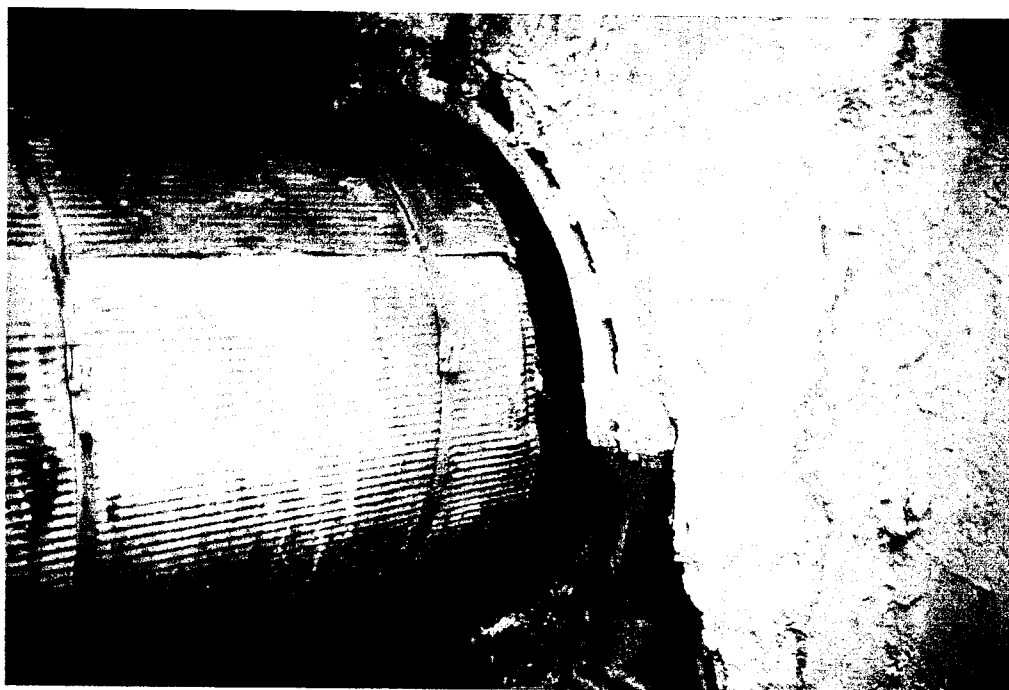
Manhole wall penetrations involved the extension of conduits through slightly oversized holes that were caulked and cemented at the interior surface of the walls. Most of the caulking at conduit wall penetrations was dried and deteriorated. Figure 17 shows a severely deteriorated manhole penetration. The caulking could not prevent groundwater infiltration into the manhole. This problem may contribute significantly to the flooding problem discussed in the previous paragraph. Also note the severe corrosion of the pipe entering the ground in Figure 17. In this example there was no evidence of the current practice, which is to use a metallic wall sleeve with a flange water stop and link seals to prevent water entry. Another problem that was frequently observed was old manhole penetrations that had not been properly sealed (Figure 18). Improper sealing provides another route for groundwater infiltration into the manhole.

Figure 17. Typical deteriorated manhole wall penetration (no. 5100), with corrosion on pipe entering the ground.

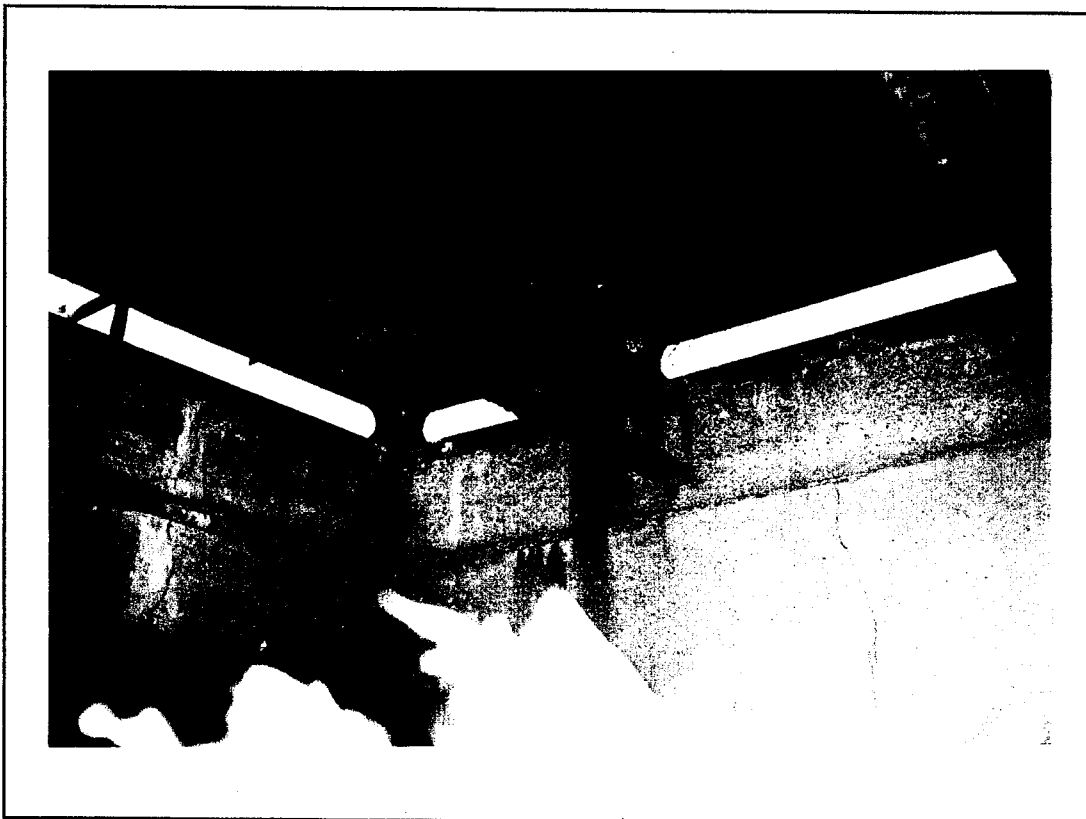
Steel beams supporting manhole walls were heavily pitted and corroded (Figure 19), as are the inner surfaces of the steel plates on the manhole tops. Manhole walls are also deteriorating, with excessive spalling and cracking evident (Figure 20). These conditions may present a future safety problem.

Figure 20. Corroded manhole support beams and cracking of manhole walls in manhole 4040.

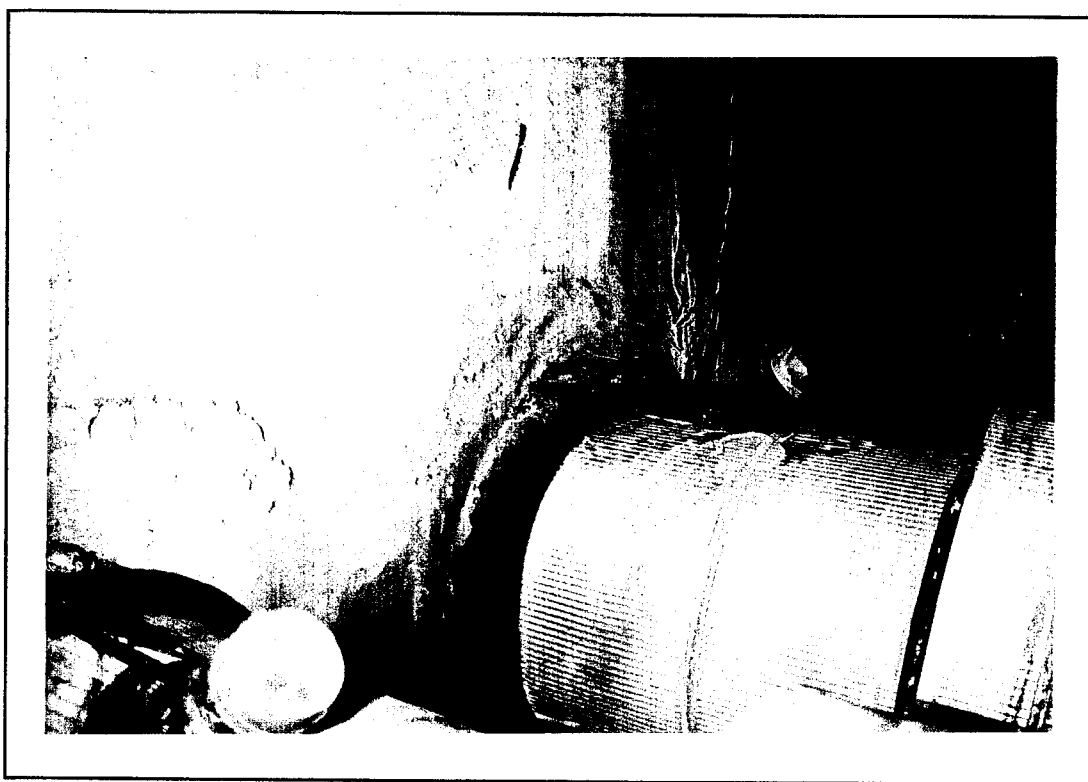
Figure 21. Plugged vents in manhole no. 4040.
